EPA Region 6 Sanitary Survey Form System Information and Contacts

PWSS Number	Water System Name	Date
061020808	Firelake Grand Casino Water System	11/20/13
Basic System Information		
Recommended Certification Level		
ODEQ level 3		
System Classification (C-NTNC-NC)	Service Area Type Code	Seasonal (Y/N) Seasonal Begin Date Seasonal End Date
C	R	N N/A N/A
Legal Entity	Name	Address Phone Number Legal Entity Code
Administrative Contact	Richard Kunze Public Works Director	1601 South Gordon Cooper Dr. Shawnee, OK 74801 404-275-3121 AC
Operator in Responsible Charge	Keith Jennings Manager	777 Grand Casino Blvd Shawnee, OK 74804 405-248-0993 DO
Utility Director		
Operator	See List on next page	
Names of Sanitary Survey Inspectors	José G. Rodriguez, US EPA Region 6 Bill Davis, Bill Davis Consulting	
Name of Operators Present	Keith Jennings

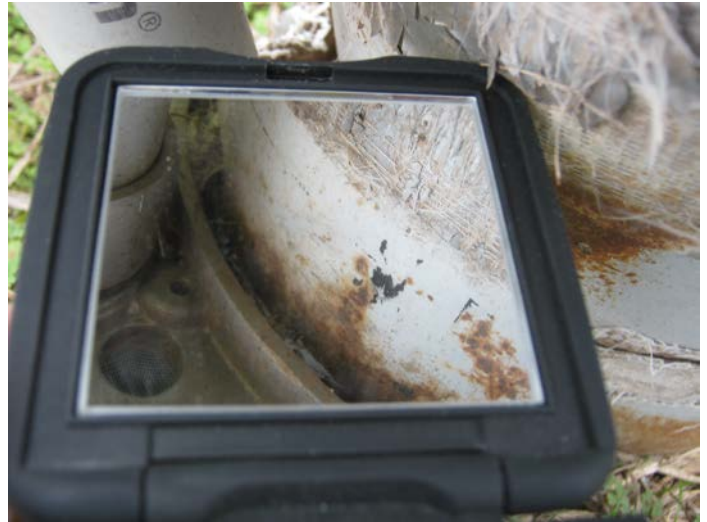
** There is a small hole next to the screen in the well cap that compromises the sanitary seal.

Small Hole next to Screen at
well K2

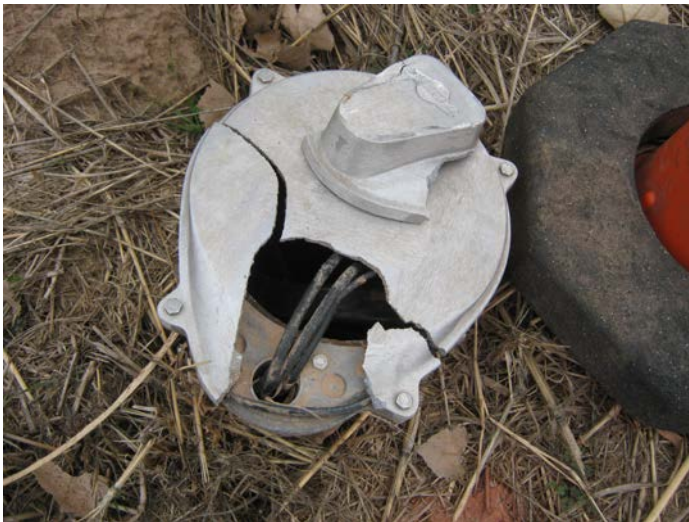
** The well cap is broken.

Well K3 showing broken well cap

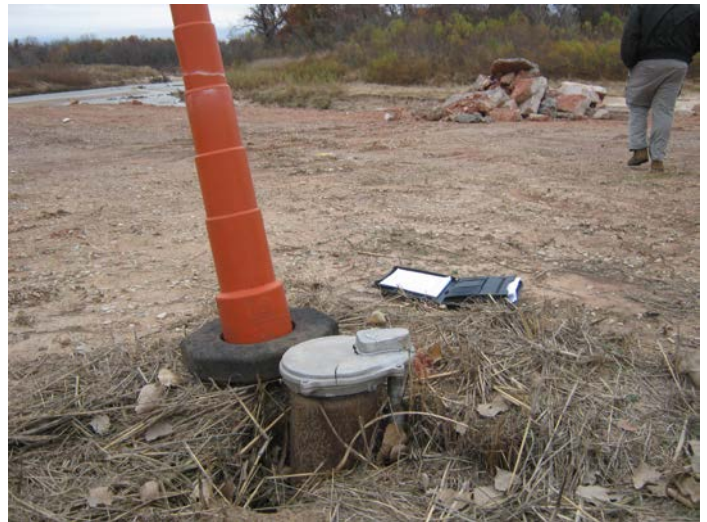
* There are plans to convert the well to vertical well and raise the casing and vent. because the well has flooded in the past.

Well K3 showing distance to
River and height of casing

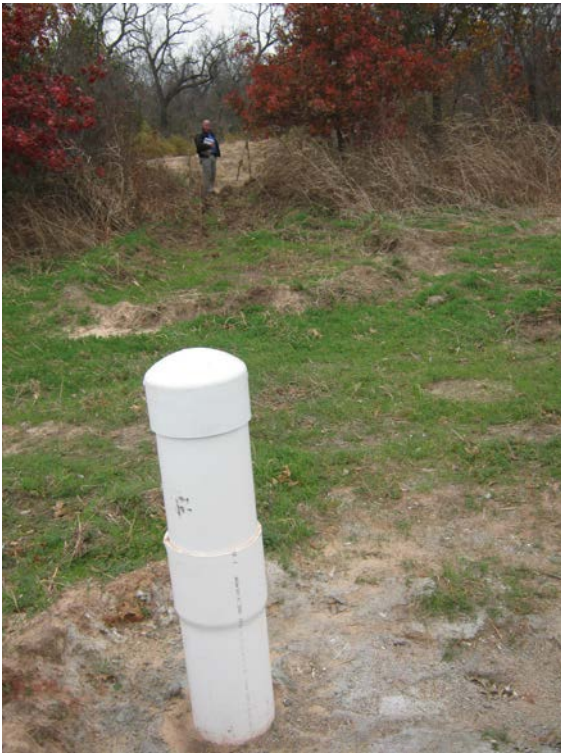
Well K4 casing showing
distance to river

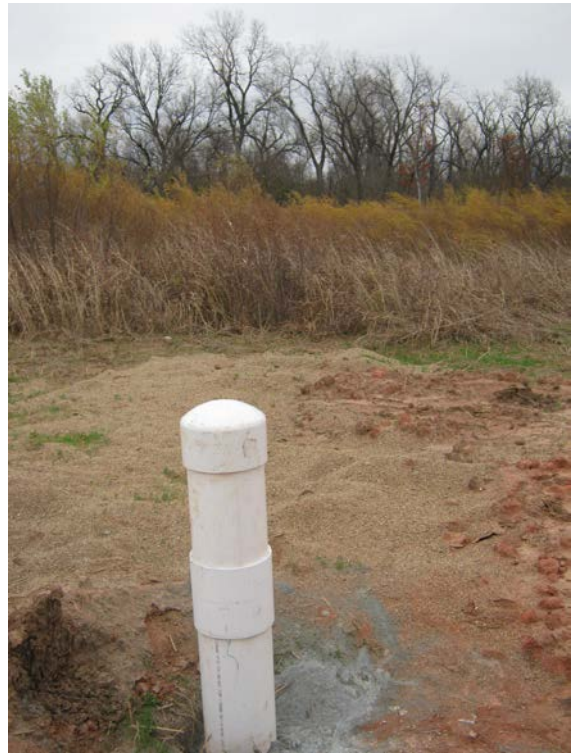
Well K5 casing showing
distance to river

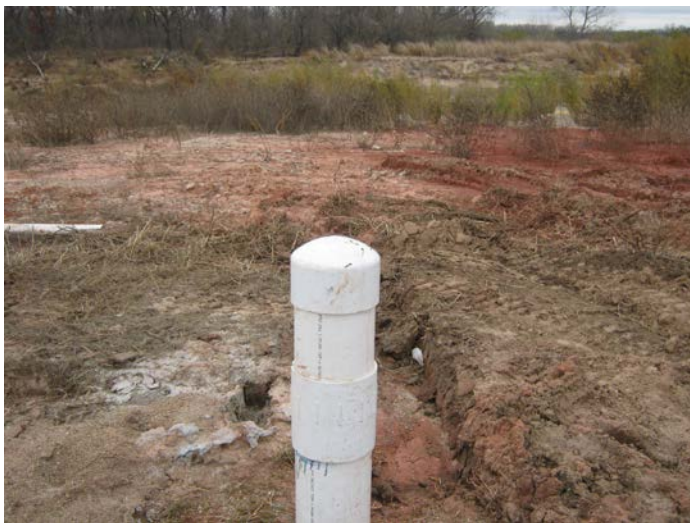
Well K6 casing showing distance
to river

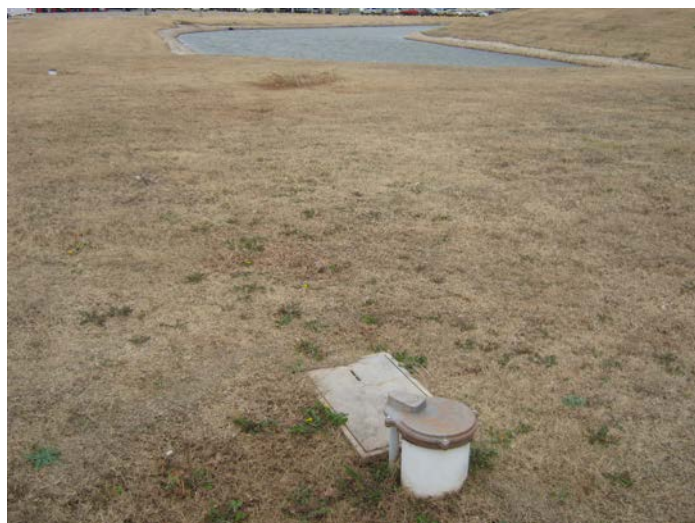
** The well is located about 20 feet from a roadway and about 100' from a pond used for geothermal cooling/heating.

South Well with Geothermal pond in background and showing casing height

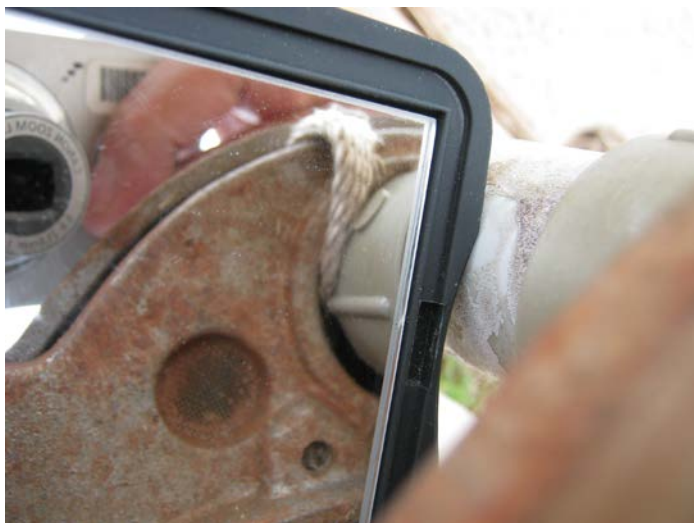
* There is a gap in the well where a rope enters the well casing, compromising the sanitary seal.

South well showing gap where rope enters the well head

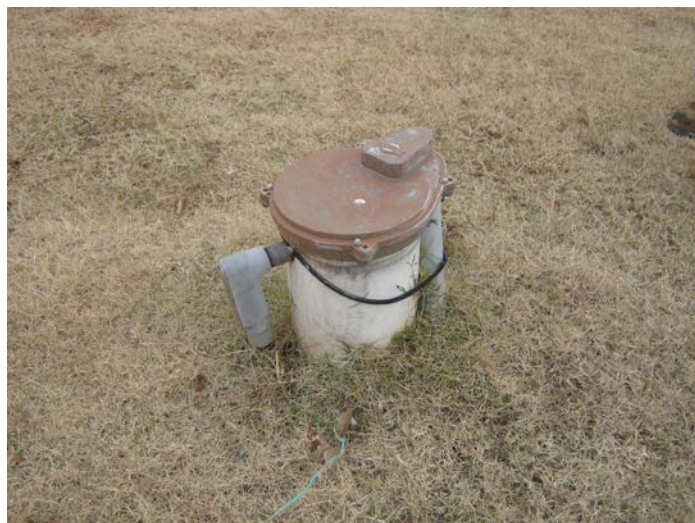
* There are gaps on both sides of the well head where electrical conduit enters.

North well showing casing height and electrical conduit on two sides.

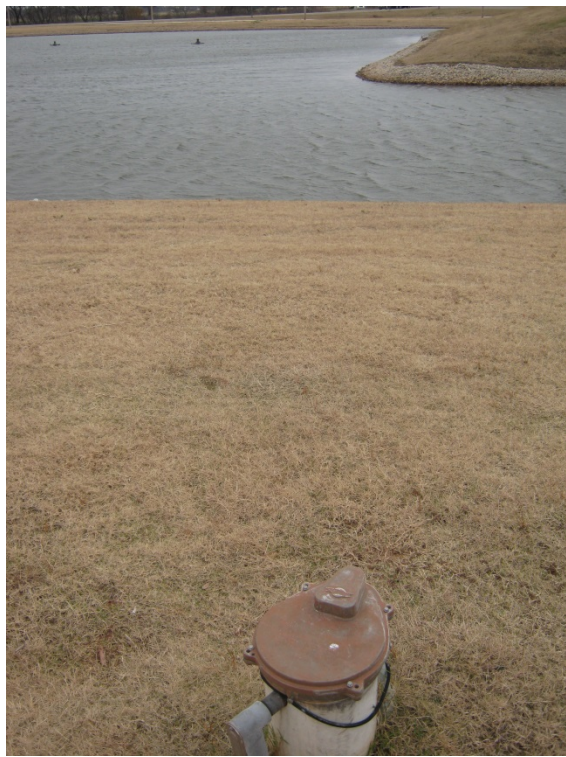
North well showing
proximity to geothermal
pond

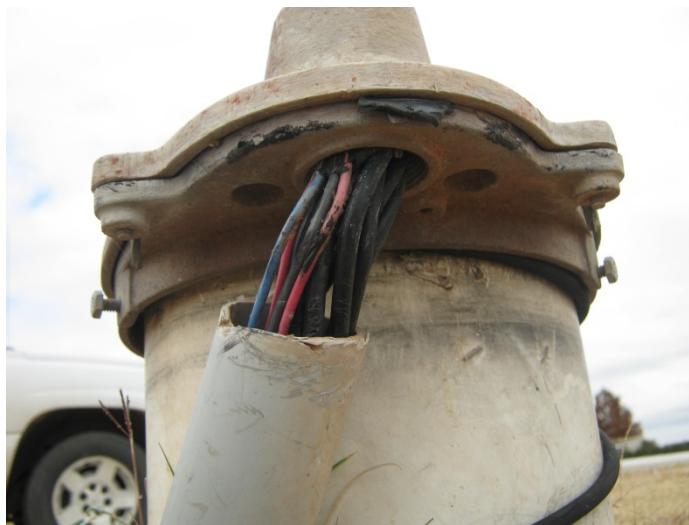
North well showing gap where
electrical lines enter on one side

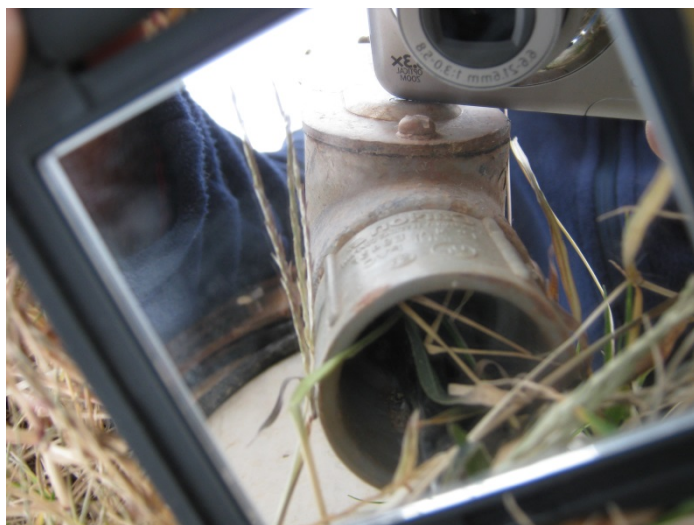
North well showing gap where
electrical lines enter the other
side

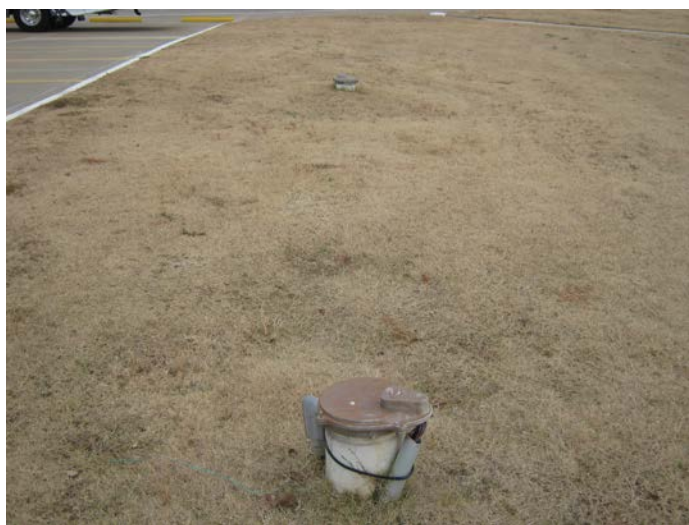
** There is an abandoned well within 20' of the well head (The abandoned well is thought to be only 1 or 2 feet deep). The well is adjacent to a run off pond used for geothermal heating/cooling.

North well showing nearby
abandoned well

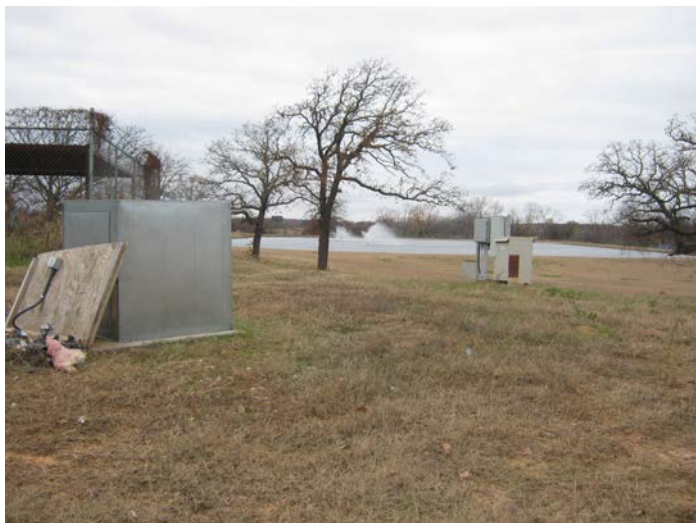
Well 3 well house showing
proximity to waste water pond

Sources	
Well 3 and Well 4	The wells are within 400 feet of a treated wastewater pond. (Plans for future wells should be submitted to EPA prior to construction to prevent similar situations.)
Batch Plant East Well	There is no screen on the Batch Plant East well air relief valve, however the well is inactive. The screen needs to be fixed before activation.
	The well cap is loose on the Batch Plant East well (inactive well needs to be corrected before being activated). It also has a hole where the electrical line enters.
Management	There is no emergency plan for the PWS (There was no previous requirement for an emergency plan but this survey will change the water system classification to <i>community</i>).
Storage	There is no gasket on the raw/gray or finished water 20K gallon storage tank hatch lids.

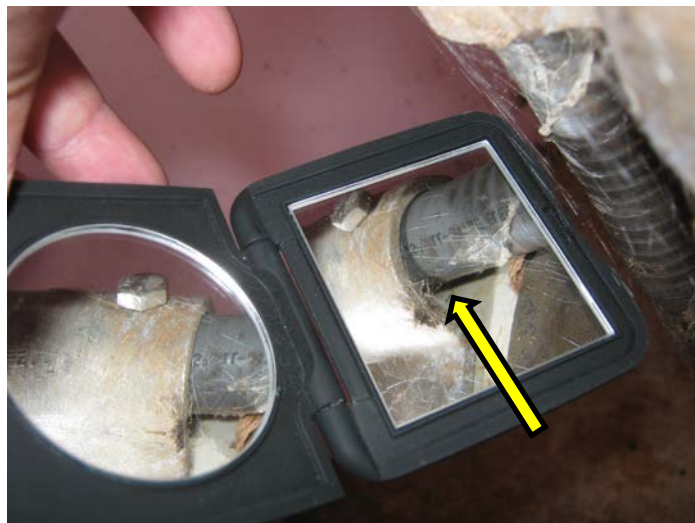
Well 3 gap where electrical line
enters well head

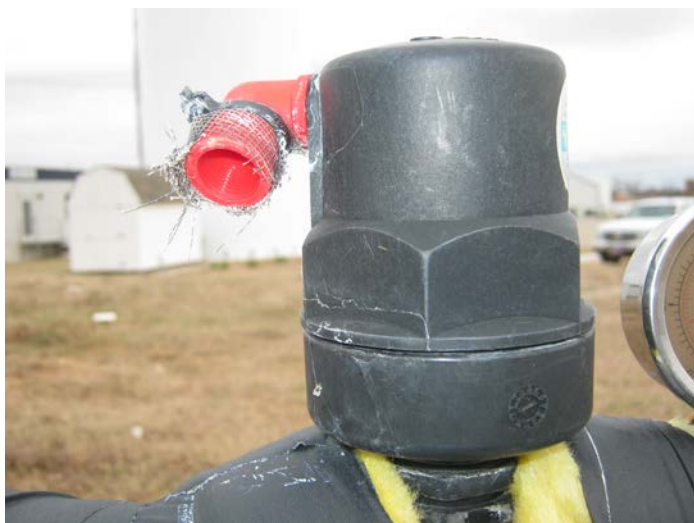
Torn screen on air relief valve at
Well 3

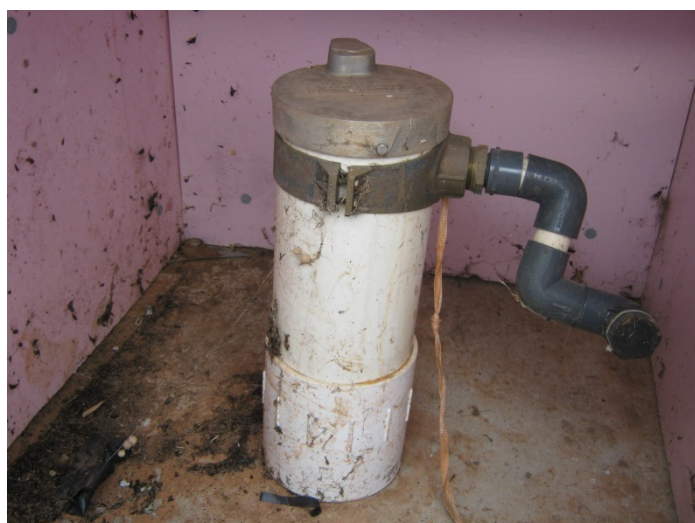
Well 3 showing vent not turned
over and too low

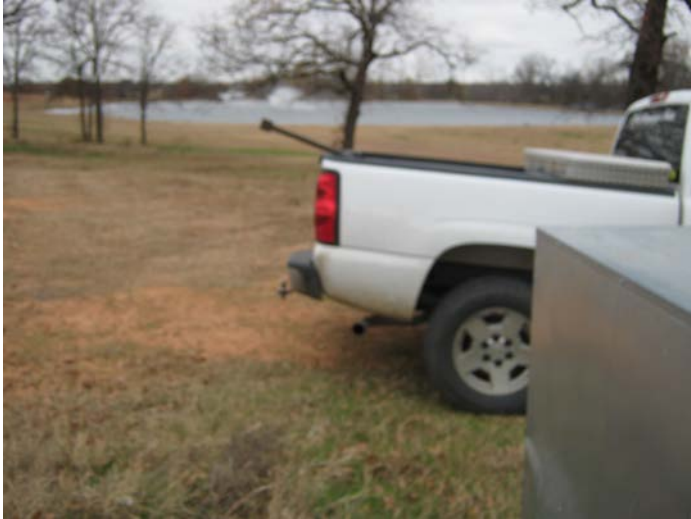
Well 4 well house showing proximity to waste water pond.

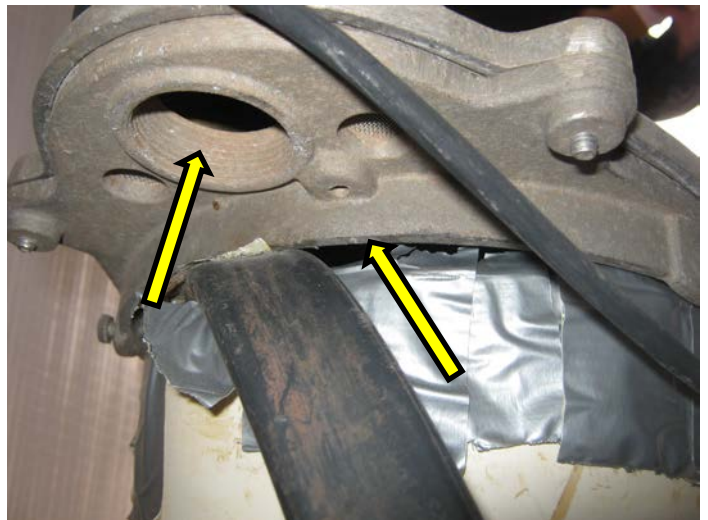
Batch Plant East Well loose well cap and hole at electrical line

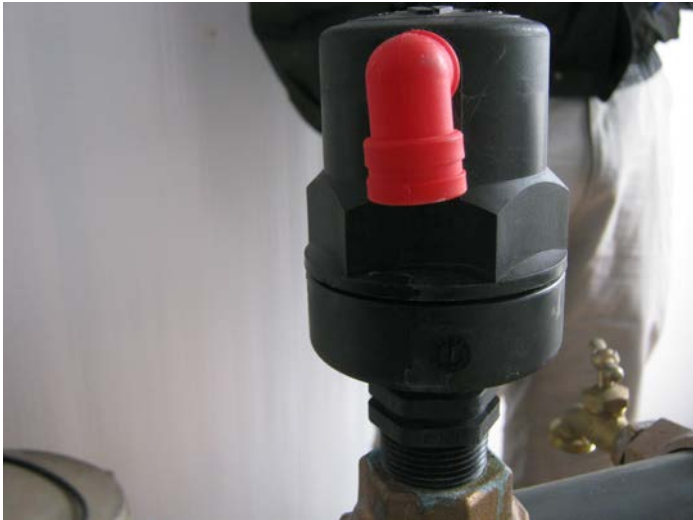
Batch Plant East Well Air relief valve unscreened

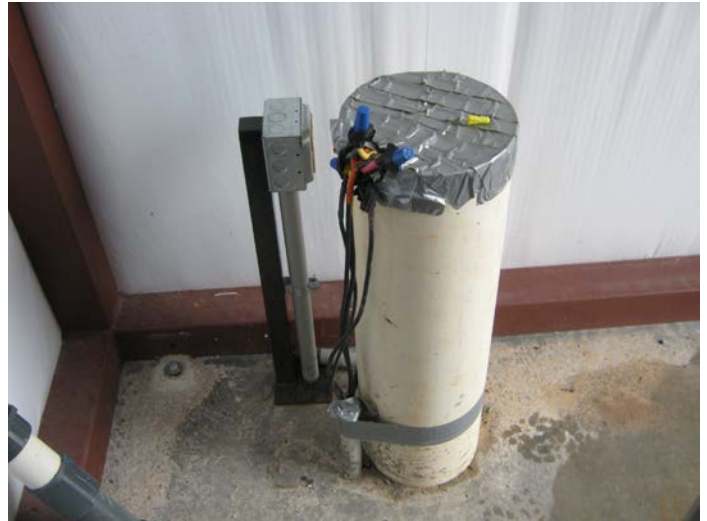
* The well head is missing the cap and is sealed with duct tape.

Batch Plant West Well showing duct tape cap, hole where electrical lines enter and lack of electrical conduit

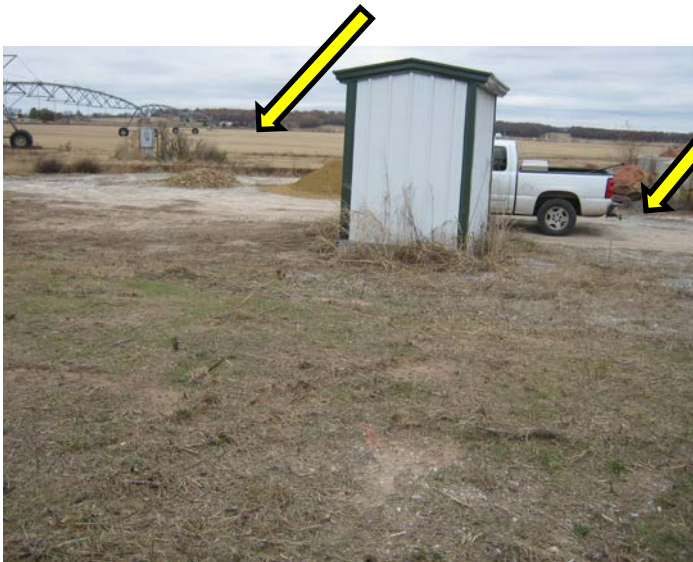
Batch Plant West well house adjacent to parking area and grass farming operations

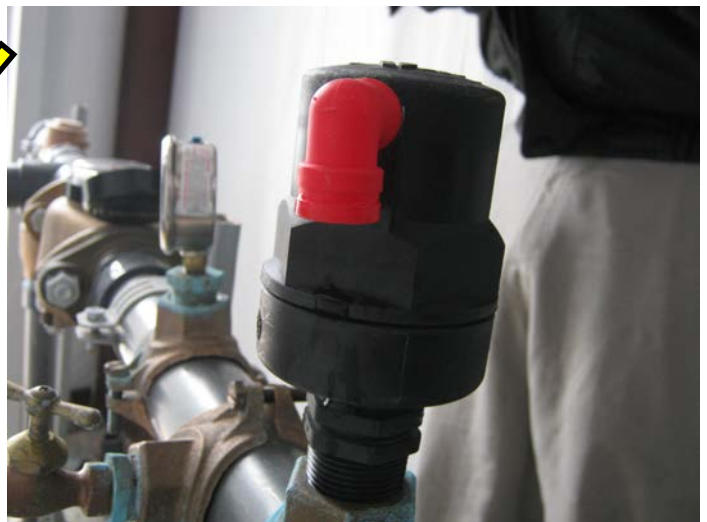
Unscreened air relief valve at Batch Plant West Well

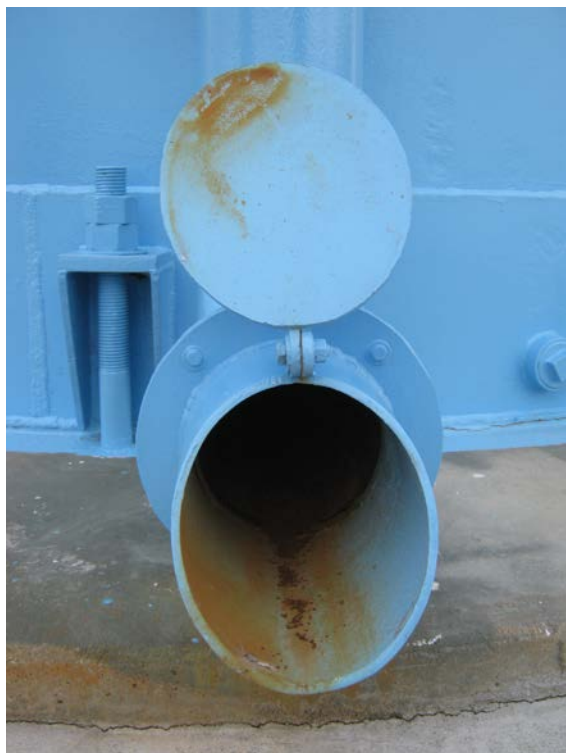
Coker standpipe overflow
showing some iron precipitate
